Miller, Garyg Garyg Miller FW: IMPORTANT. Fwd: San Jacinto - Hurricane Harvey Monitoring

Pictures from the San Jacinto cap at noon on Sunday 8/27/17.

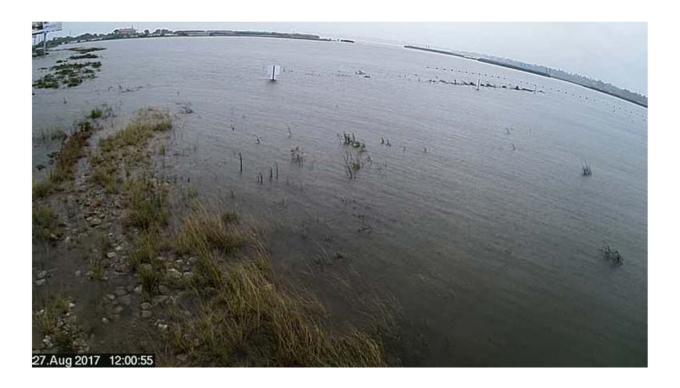
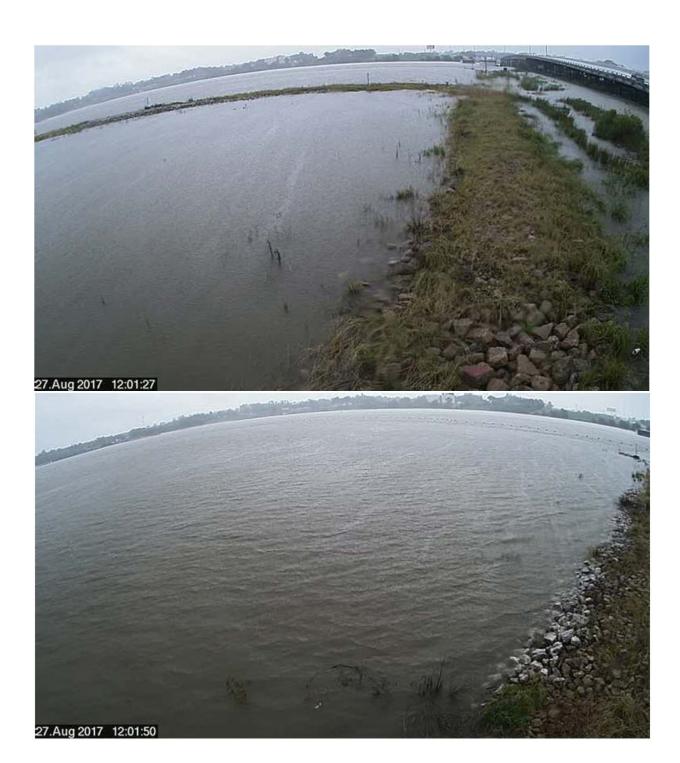
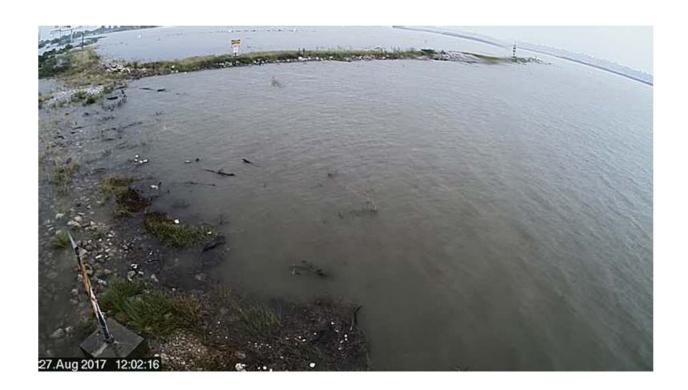
The San Jacinto River gauge at Sheldon, about 6 miles north of the site, was 12.5-ft (normal 1 – 2-ft) at the that time of the pictures; the current stage is 20.75-ft, or about 8-ft higher than at the time of the pictures, so expect all of the berms to be completely underwater now. The river is currently rising about ¼-ft per hour.

The pictures below show water covering most of the cap, with some of the berms already underwater & others only a foot or so above the water.
